NEW YORK STATE
DEPARTMENT OF TRANSPORTATION

GEOTECHNICAL CONCEPTS REPORT

SR 443 Delaware Avenue Landslide

Elsmere, New York

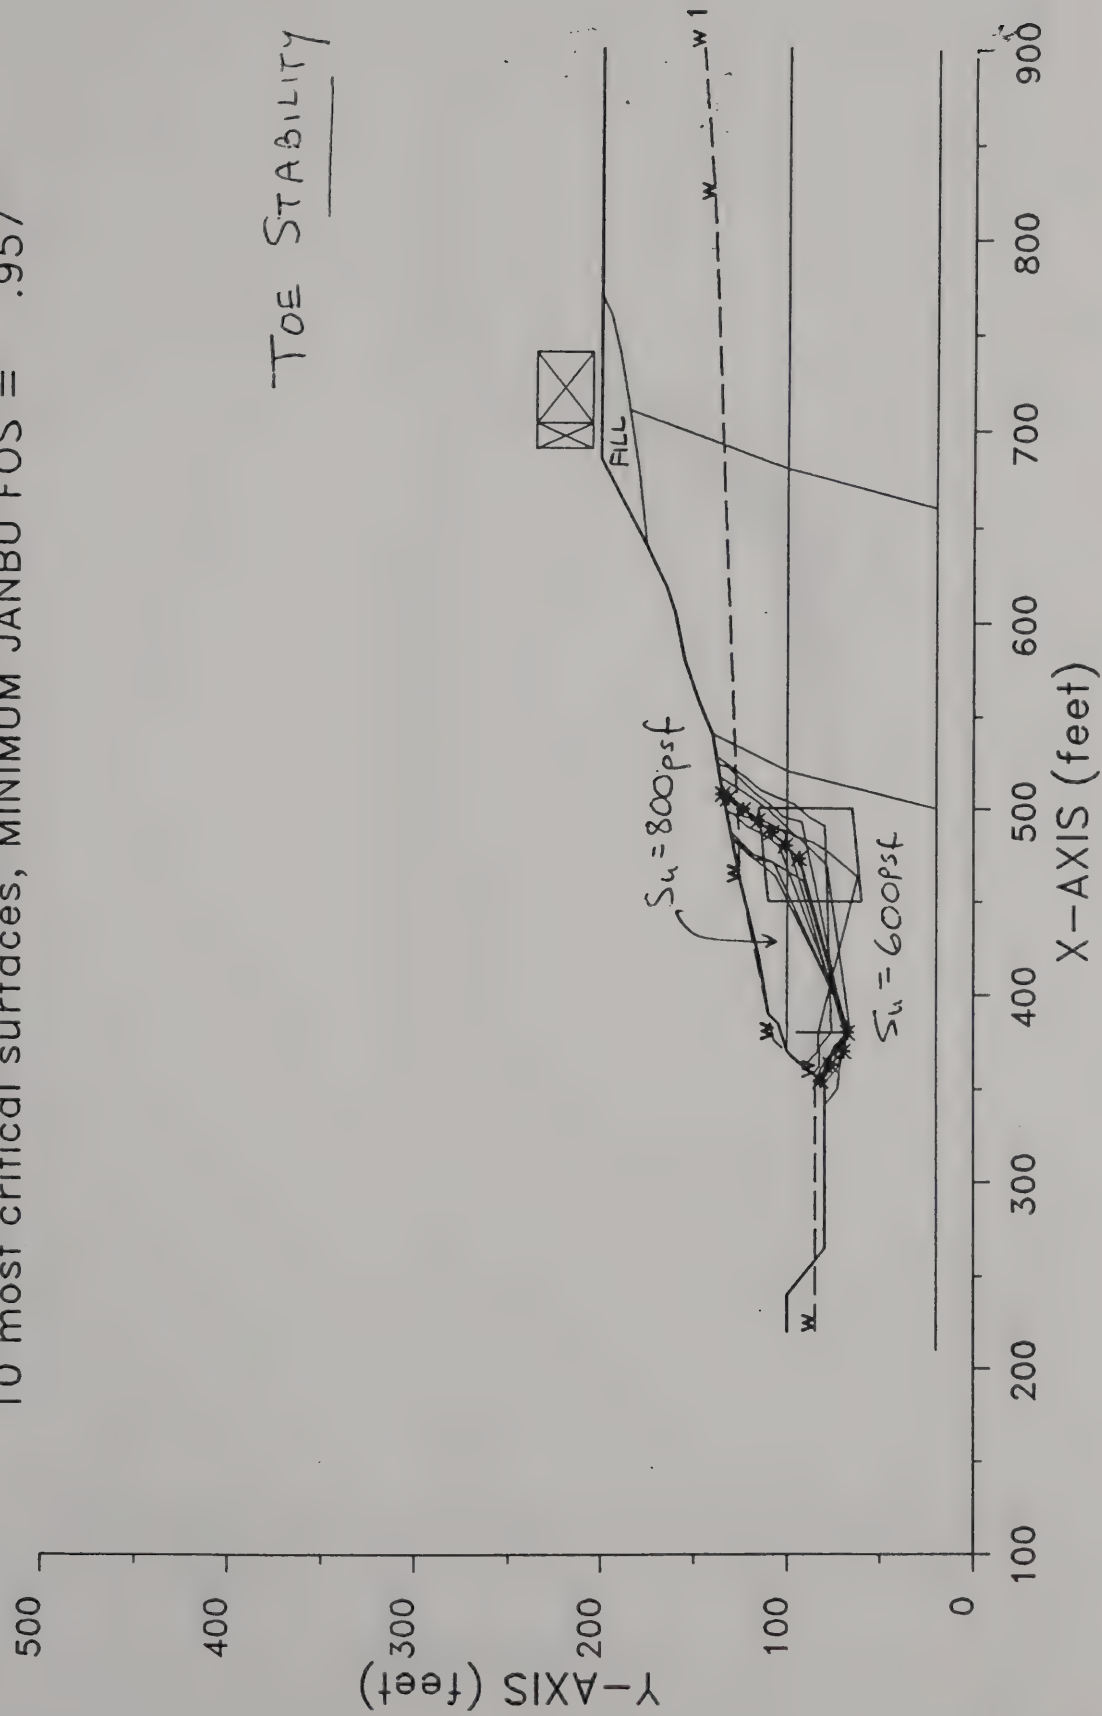
Normans Kill Slide, Initiate, toe
 10 most critical surfaces, MINIMUM JANBU FOS = .957

TOE STABILITY

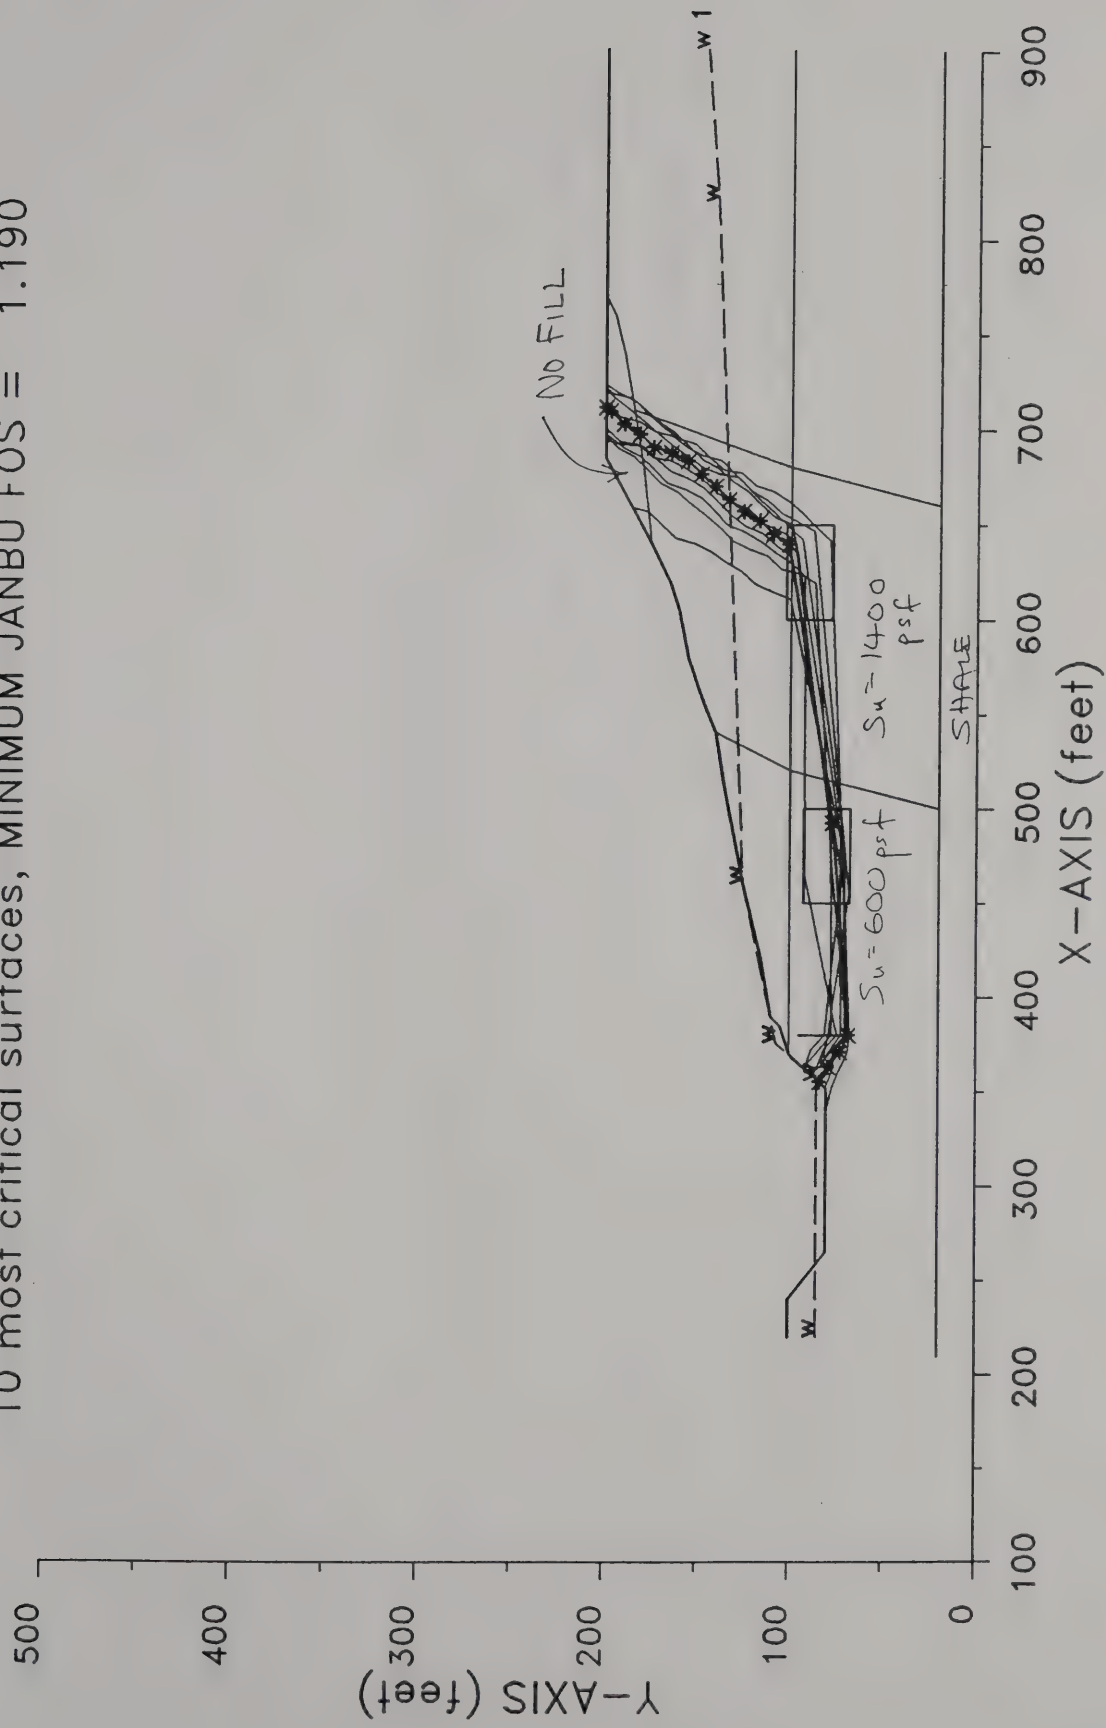
Normans Kill Slide, Initiate, no fill
10 most critical surfaces, MINIMUM JANBU FOS = 1.190

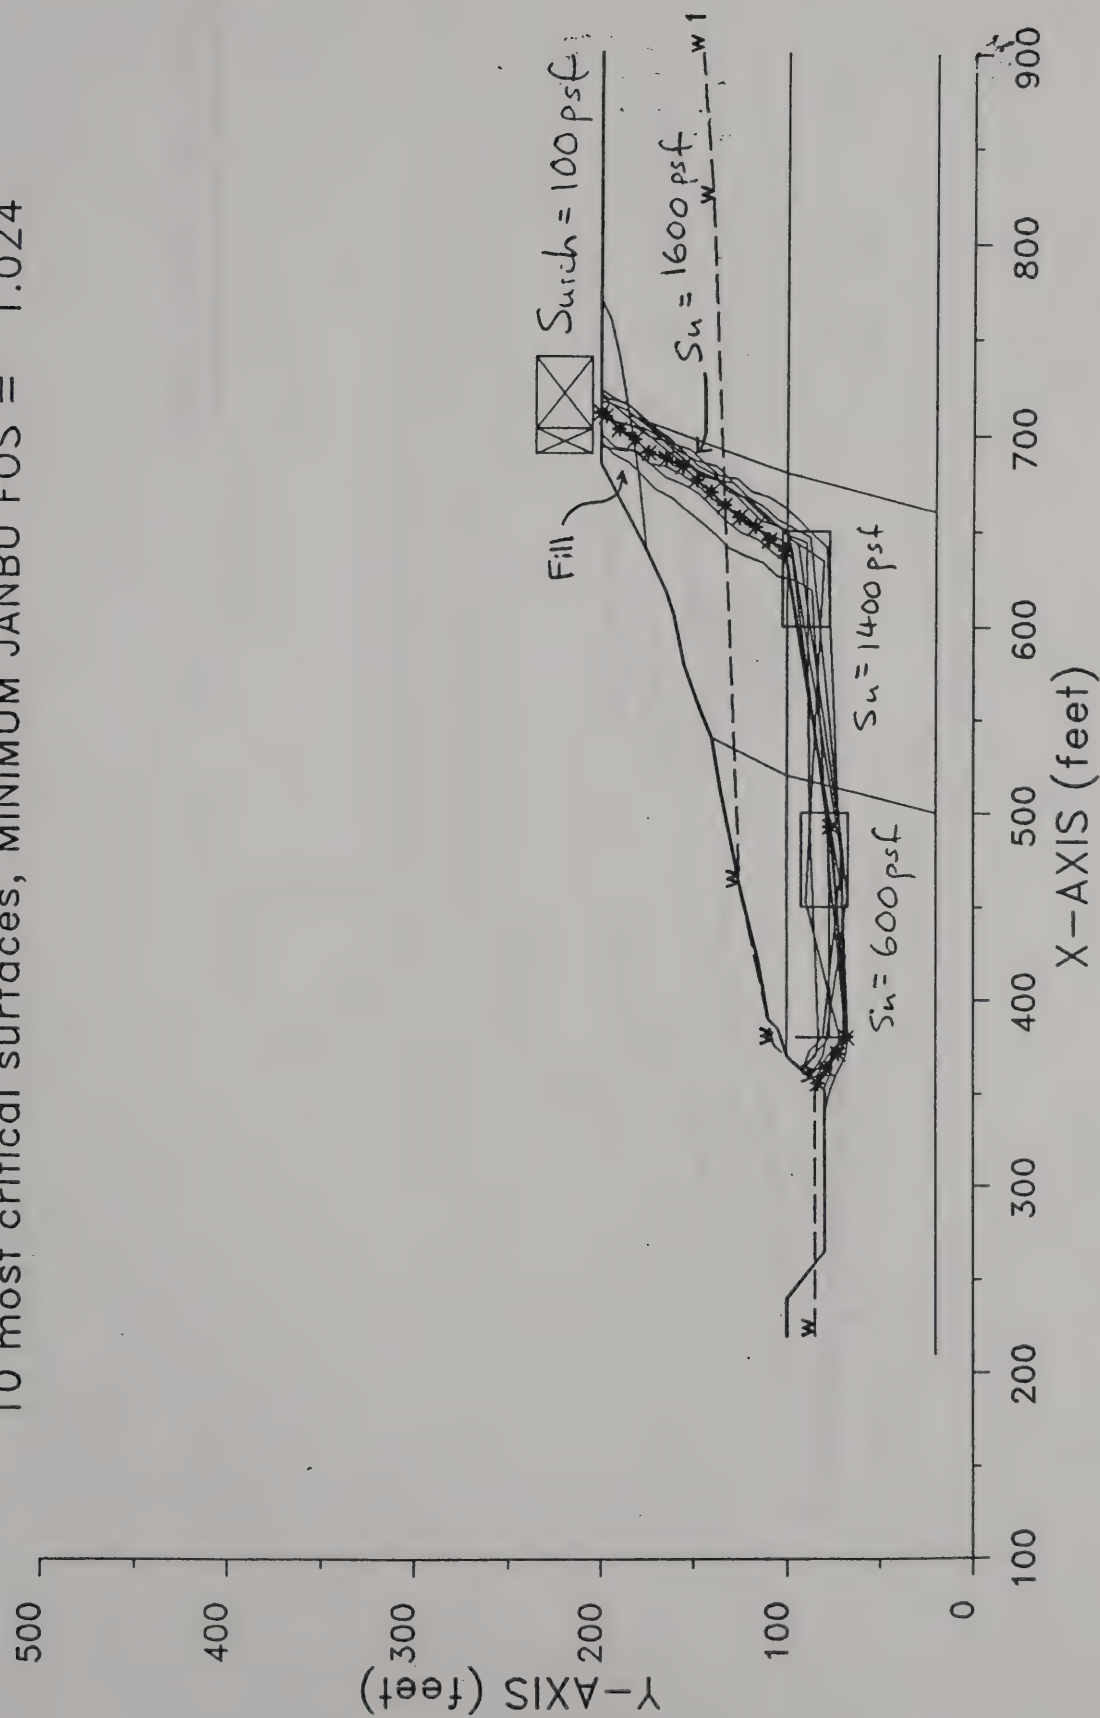
Normans Kill Slide, Initiate, surch
10 most critical surfaces, MINIMUM JANBU FOS = 1.024

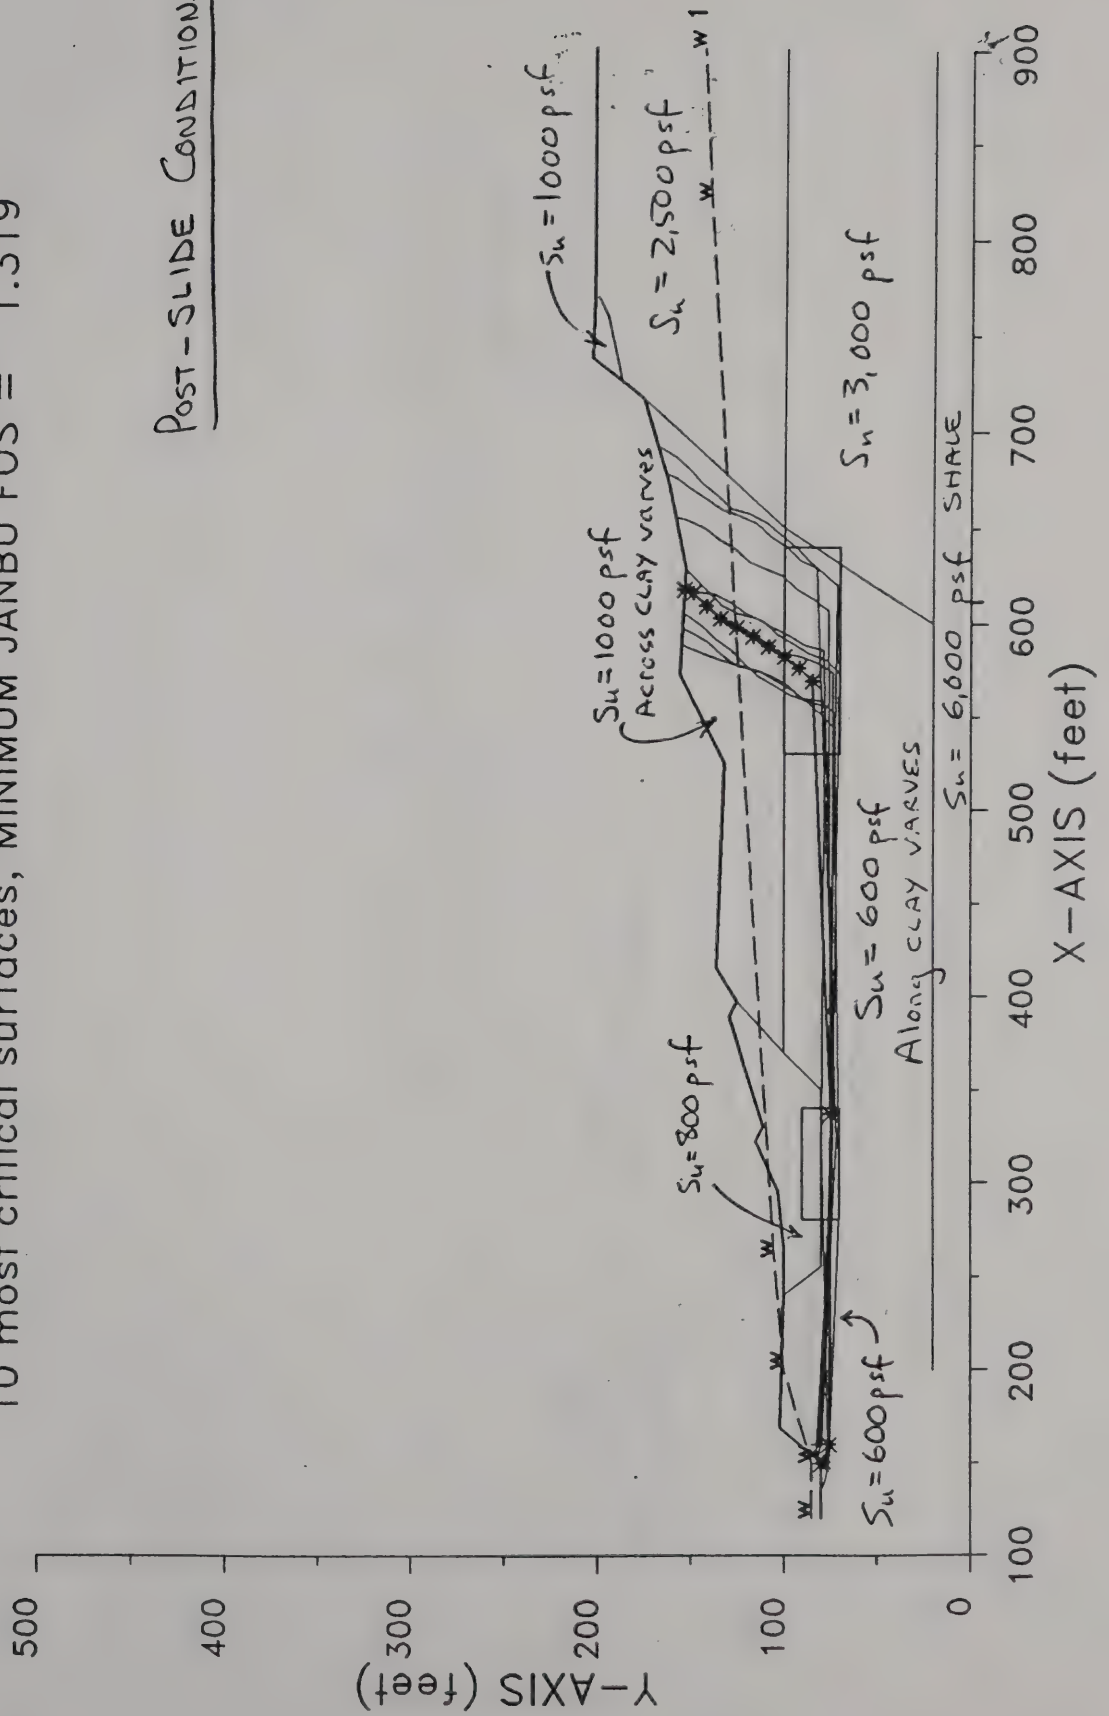
Normans Kill, total stress, gwt 140'
 10 most critical surfaces, MINIMUM JANBU FOS = 1.319

POST-SLIDE CONDITIONS

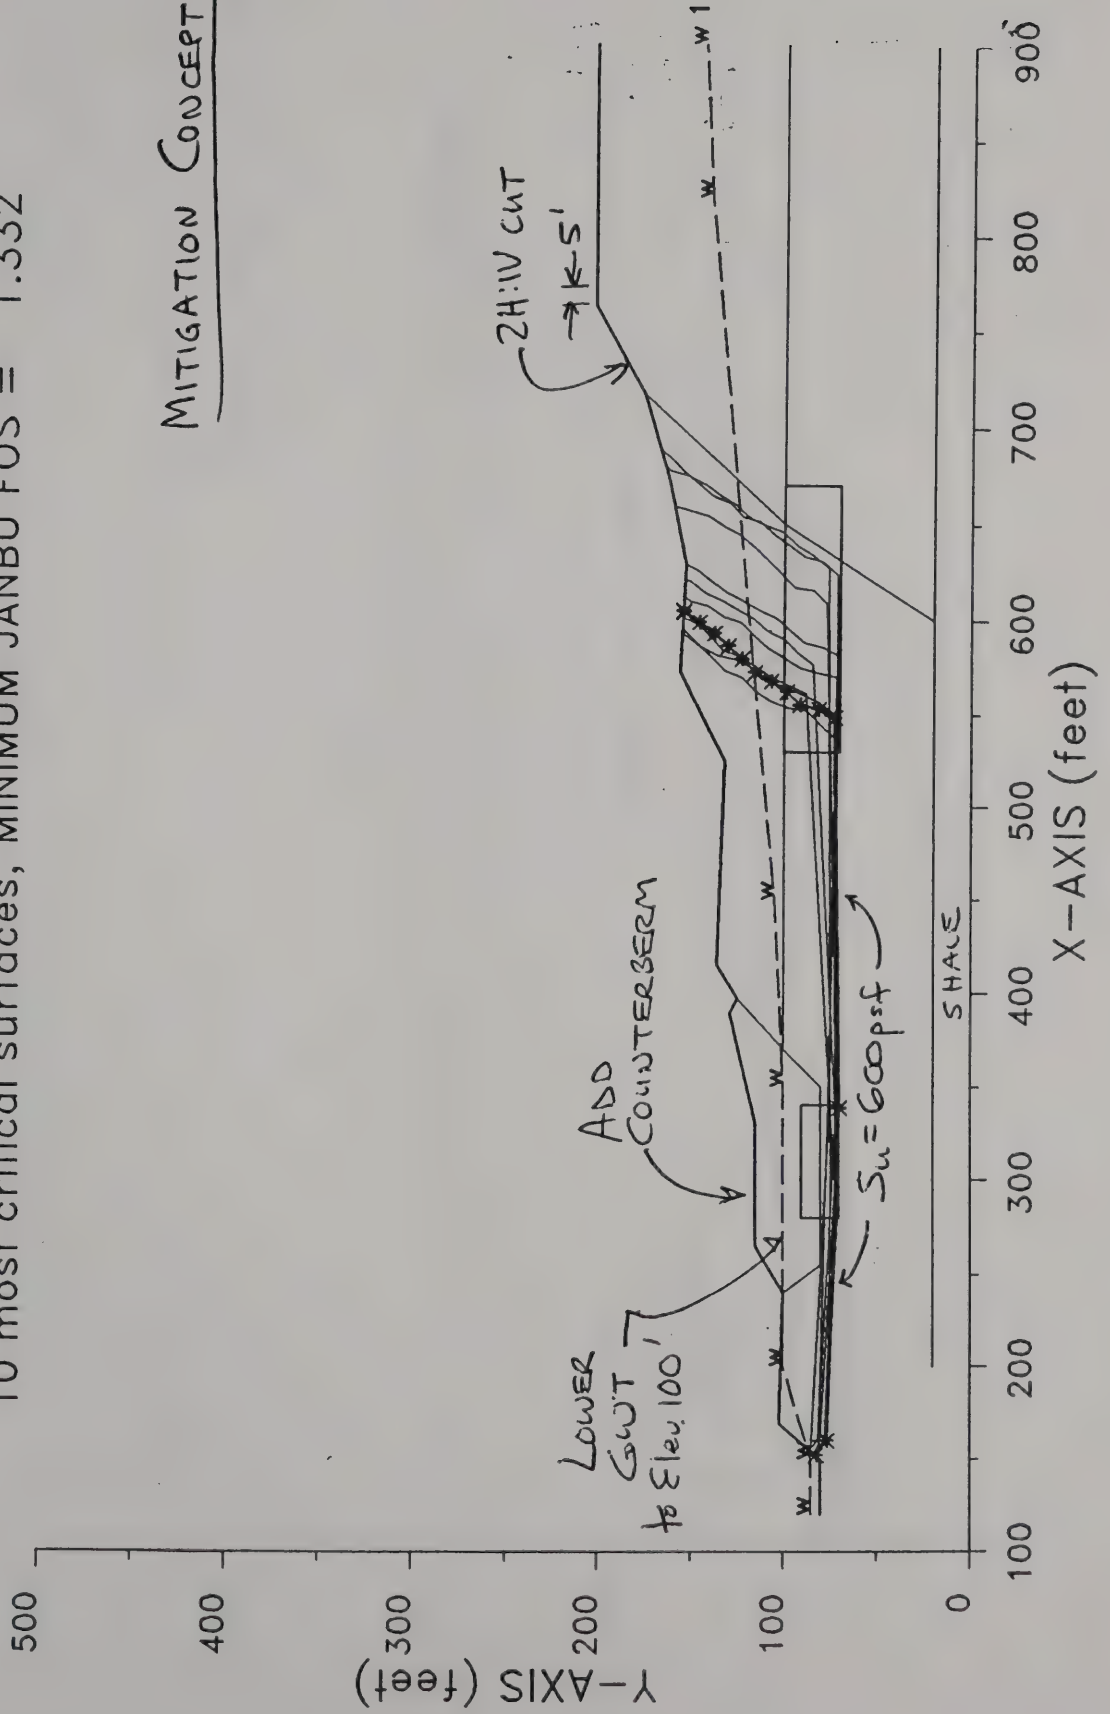
Normans Kill, total stress, gwt 140'
 10 most critical surfaces, MINIMUM JANBU FOS = 1.332

MITIGATION CONCEPTS

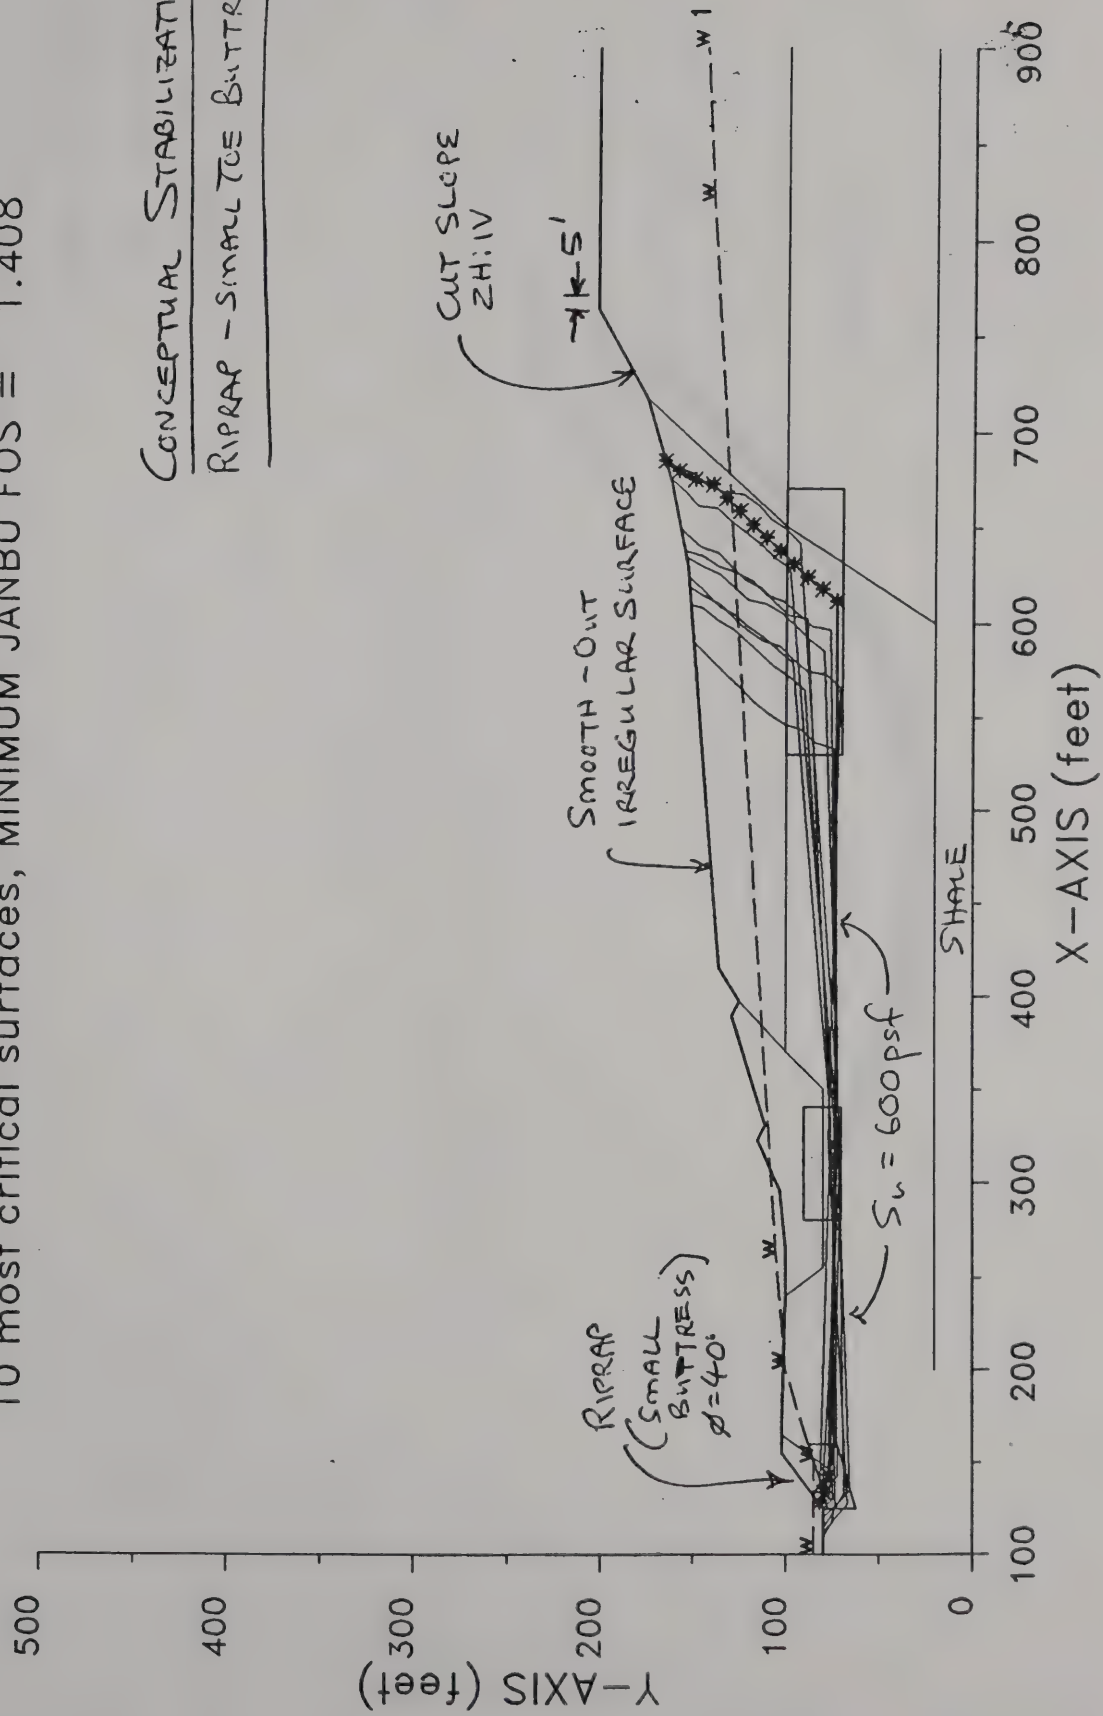
Normans Kill, total stress, gwt 140'
 10 most critical surfaces, MINIMUM JANBU FOS = 1.408

CONCEPTUAL STABILIZATION
RIPRAP - SMALL TOE BUTTRESS

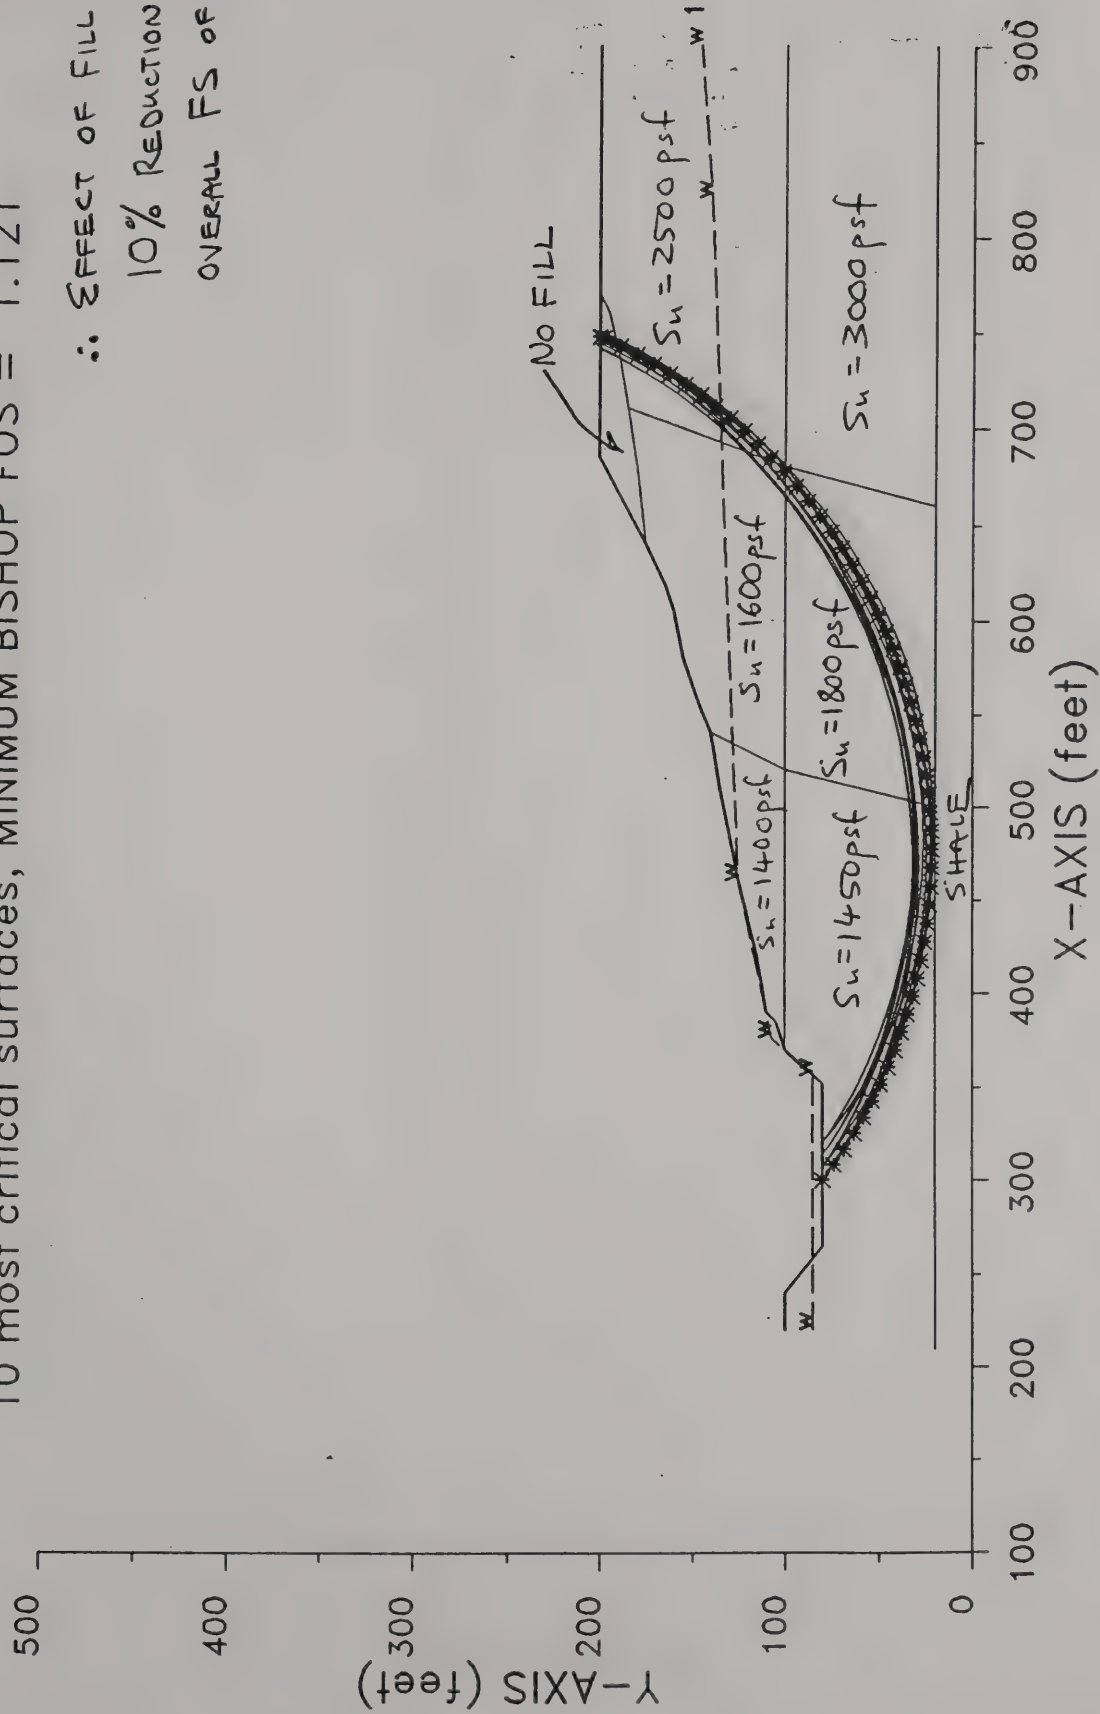
Normans Kill Slide, Initiate, no fill

10 most critical surfaces, MINIMUM BISHOP FOS = 1.121

∴ EFFECT OF FILL ~
10% REDUCTION IN
OVERALL FS OF SLOPE.

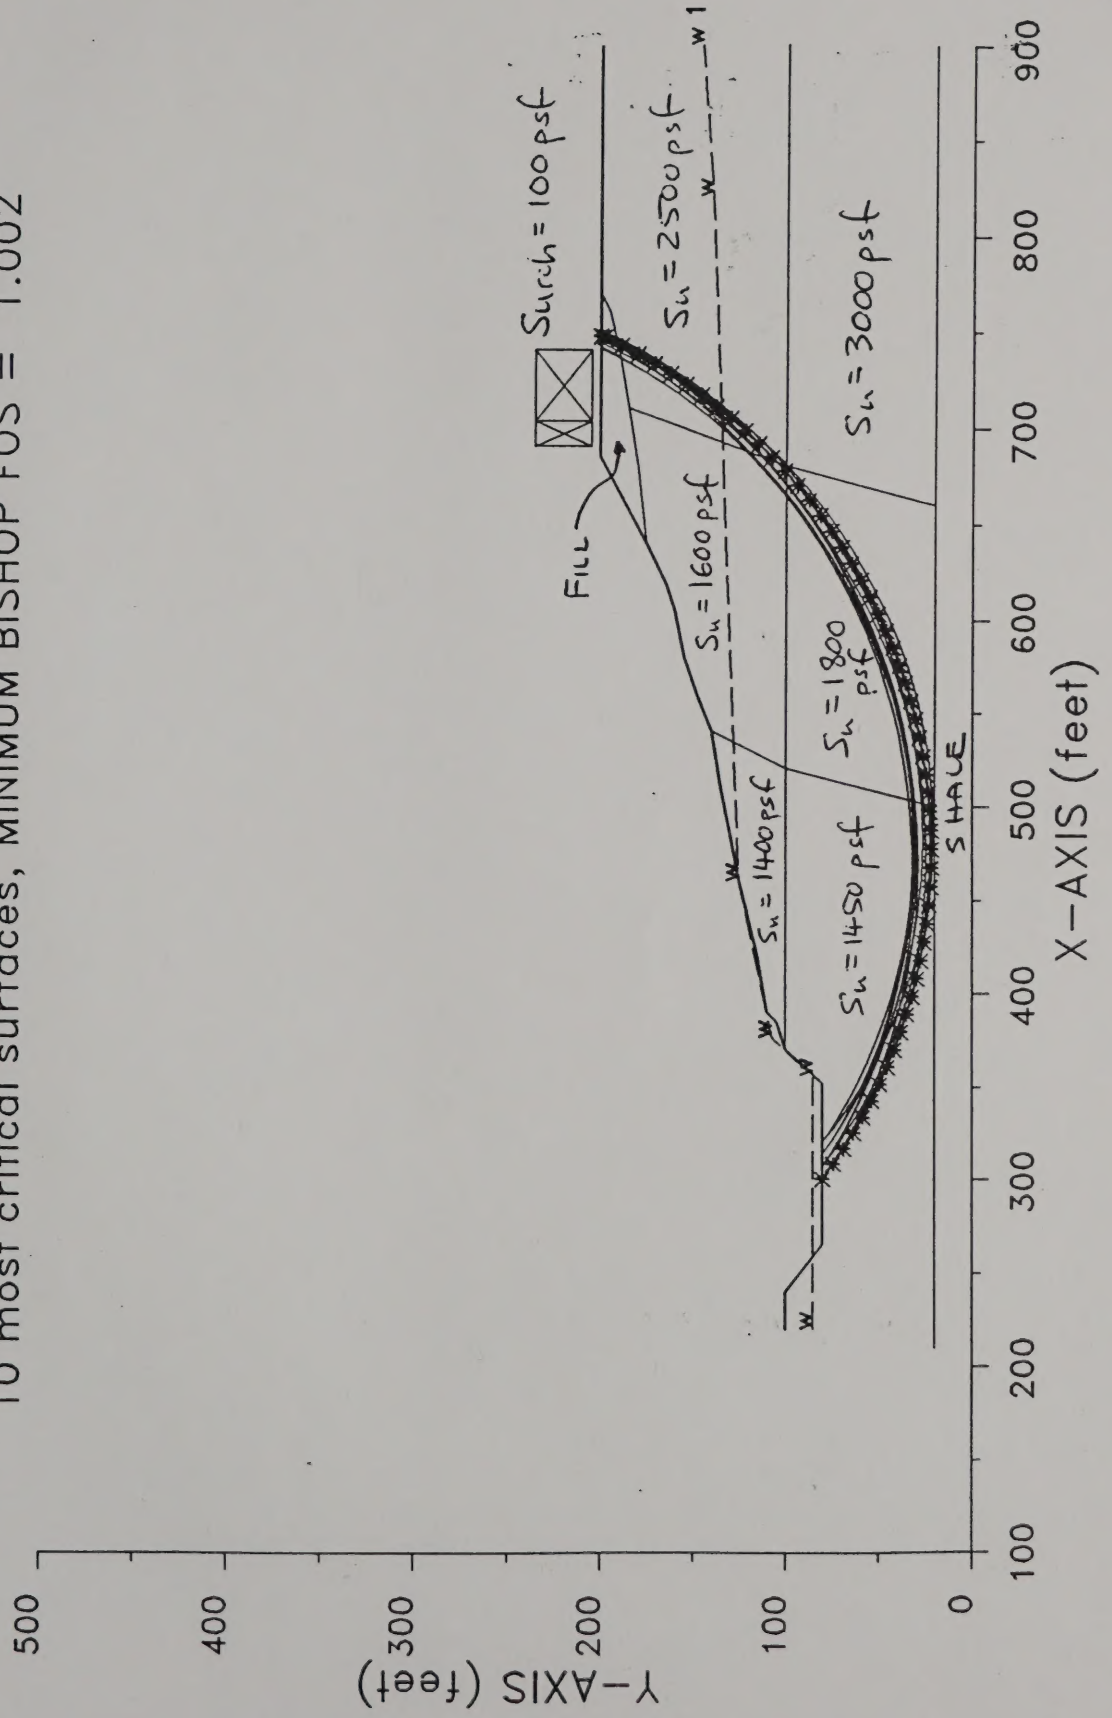
Normans Kill Slide, Initiate, surch
 10 most critical surfaces, MINIMUM BISHOP FOS = 1.002
